Next Navigation East:

Part 14: Design Elements V: Tunnels

14 Design Elements V: Tunnels

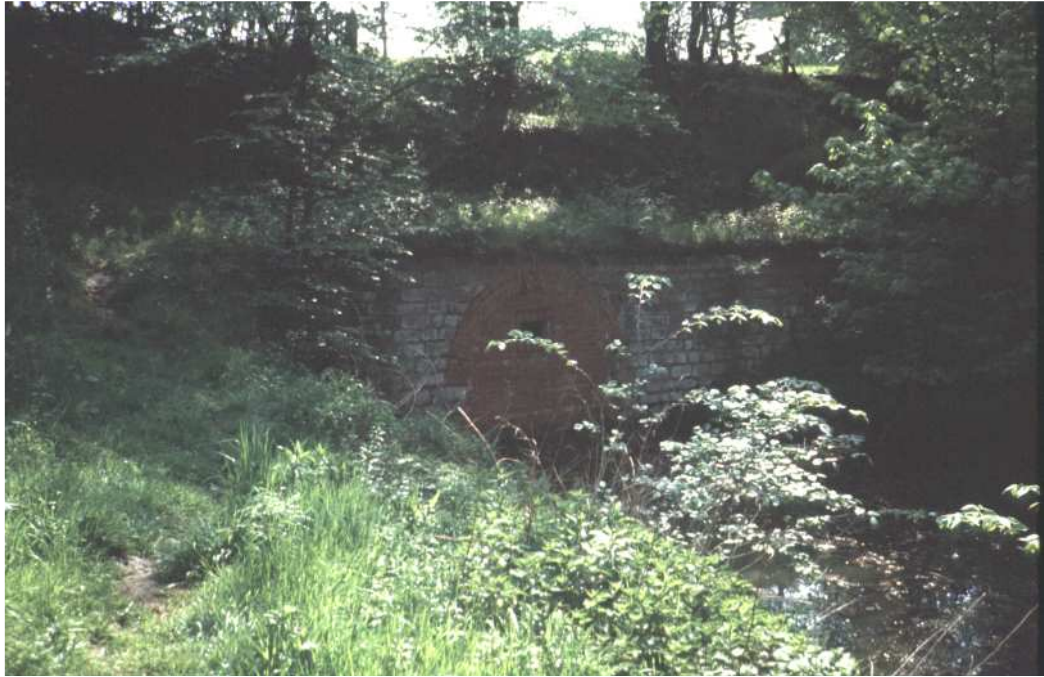
Figure 14.1 Norwood Tunnel Western Portal

14.6.1 The western portal takes the form of a simple arched opening in a vertical stone wing wall. The wall is composed of coal measure sandstone blocks laid in roughly half-overlapped mortared courses. The block heights are consistent at around 0.25 to 0.3 m and the resulting horizontal courses appear straight regular; the block lengths are less regular and vary from 0.45 to 0.25 m, leading to an irregular vertical overlap with the blocks below. The wall is completely plain and lacks any form of ornamentation or decoration.

14.6.2 The tunnel arch consists of three rings of hard red brick sitting on a footing of sandstone blocks keyed into the wall courses. Five courses of keyed sandstone blocks are visible above water level before commencement of the brick arch which extends through eight stone courses and is capped by a single course of stone.

The west portal of Norwood Tunnel photographed by Hugh Potter in 1972. ((C) Hugh Potter)

- 14.6.3 It is uncertain if this interesting composite arch is original or results from the partial replacement of an original stone arch during the raising of the tunnel roof in the 1870's (above). It is noticeable that the projected centre and radius of the partial arch formed by the keyed stone blocks is different from the arch centre and radius of the brick arch leading to the portal having a slightly elliptical appearance. This may support the notion that the current arrangement is not original and results from the reconstruction.

- 14.6.4 At present the tunnel arch is infilled with a lighter soft red brick with a single rectangular opening in the middle of the blocking wall. This opening is closed with a series of vertical bars. Through the bars it is possible to see that the tunnel roof has collapsed into the passage space within approximately 5 to 10 metres of the opening.

- 14.6.5 The tunnel level summit pond is still in water and this runs up to foot of the blocking wall. The curtain wall is visible and in reasonable condition with no obvious indications of immanent collapse. Much of area round the wall is overgrown especially in the summer. For example, the site of the Tunnel Keepers cottage and the stables to the left and above the tunnel entrance can only be seen in the winter when the vegetation is low.

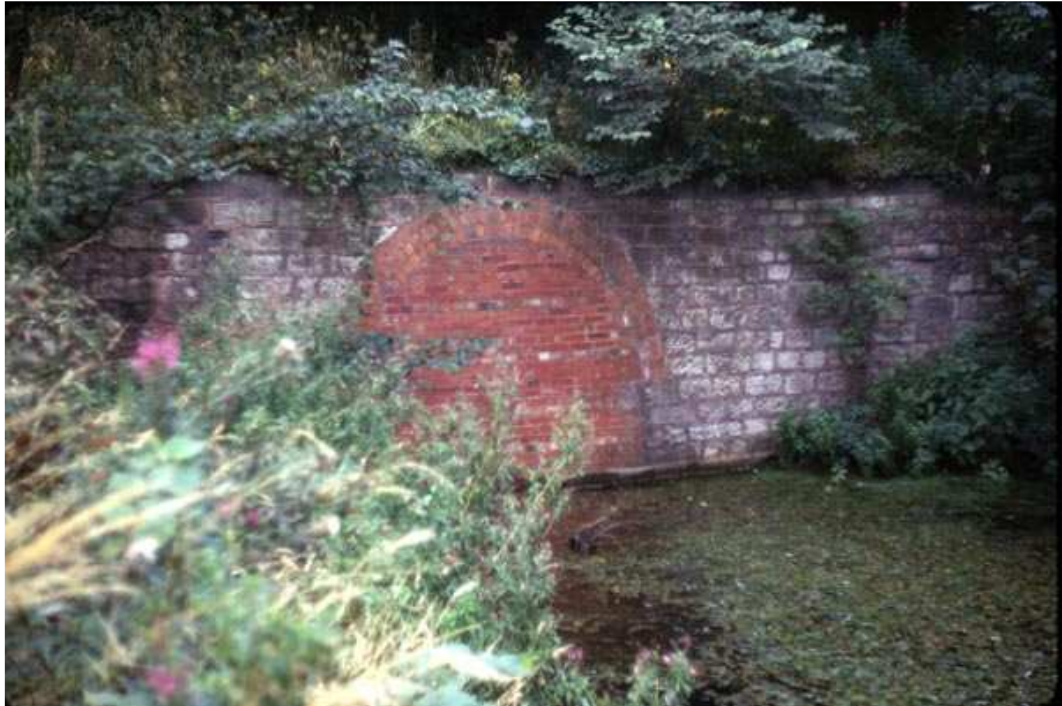
Figure 14.2 Norwood Tunnel Eastern Portal

- 14.11.4 The eastern portal is the twin of the western one and is no more adorned. It consists of a straight limestone retaining wall in coursed rectangular blocks. The main arch of the tunnel is roughly central to the wall and is formed of three rings of hard red brick. The entrance itself is infilled with a red brick wall. This has no openings.

The east portal of Norwood Tunnel photographed by Hugh Potter in 1972. ((C) Hugh Potter)

- 14.11.6 The Eastern Portal forms the current limit of navigation on the restored canal from West Stockwith to Kiveton Park. The retaining wall is in good condition as was re-pointed by British Waterways as part of the restoration programme. During that programme the blocking wall was partially take down and the tunnel entered and surveyed. At the end of the survey the wall was re-erected.
- 14.11.7 The blocking wall at the eastern end of the tunnel has no openings and the tunnel did not provide a roost for bats at the time of the last inspection. In consequence this is not envisaged to be an issue at this end.
- 14.11.8 The Canal is fully navigable as far as the blocking wall – no works outside the removal of the wall and the dredging of recent accumulations in front of the wall are required.
