Part 20: Design Summary for Restoration Section 8: Norwood

20 Design Summary for Restoration Section 8: Norwood

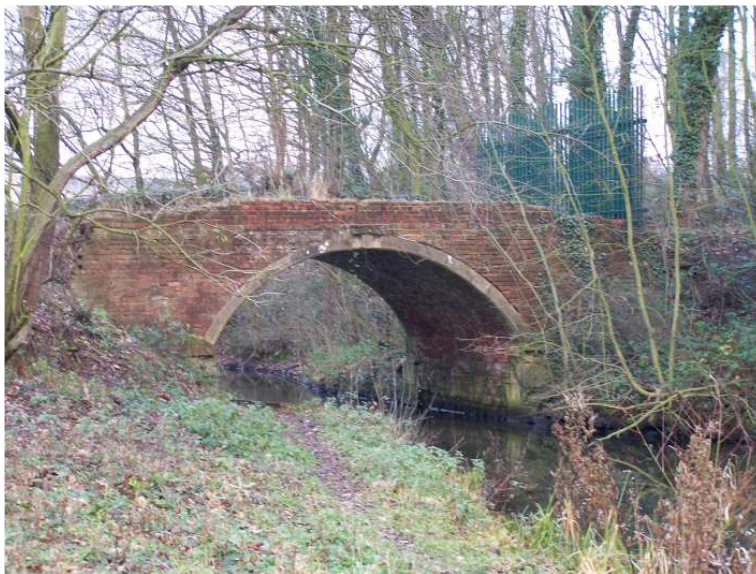
Figure
20.1

Norwood Bridge
(No.30) looking east.

Bridge extensively rebuilt c. 1832. Grade 2 listed, damaged by inappropriate landowner modifications. The start of the Norwood section.

- 20.5.7 Norwood Bridge at the foot of the Flight has been badly damaged by unsympathetic modifications by the owner. The structure is grade II listed but no enforcement action has been taken by RMBC to date.
- 20.5.8 Extensive repairs to Norwood Bridge will need to be carried out as soon as is practicable.
- 20.5.9 Two new accommodation bridges will need to be constructed to provide access to the Houses at the top and bottom of the Flight. It is possible that one or more of these bridges will need to be of either the lifting- or swing-bridge type.

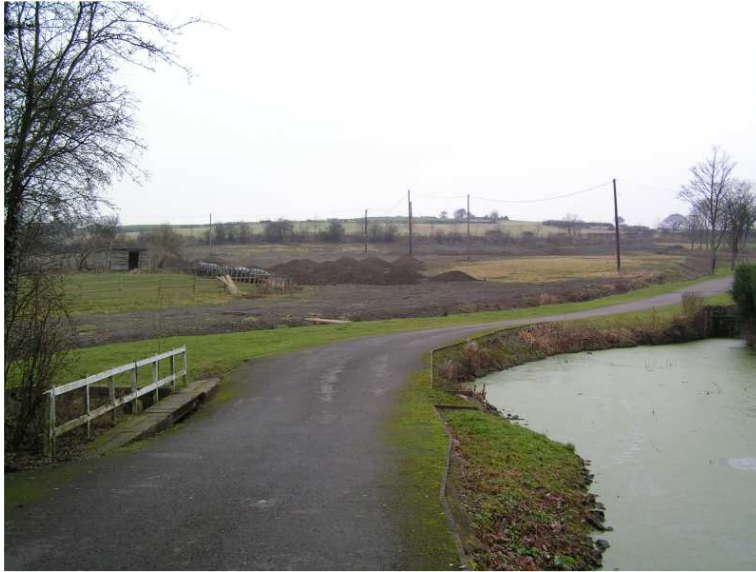
Figure 20.2

Norwood Low Side Weir looking east.

The weir is marked by the handrail and footway on the left side of the roadway – the weir itself (originally a ford like arrangement) has been infilled and tarmaced over by the landowner.

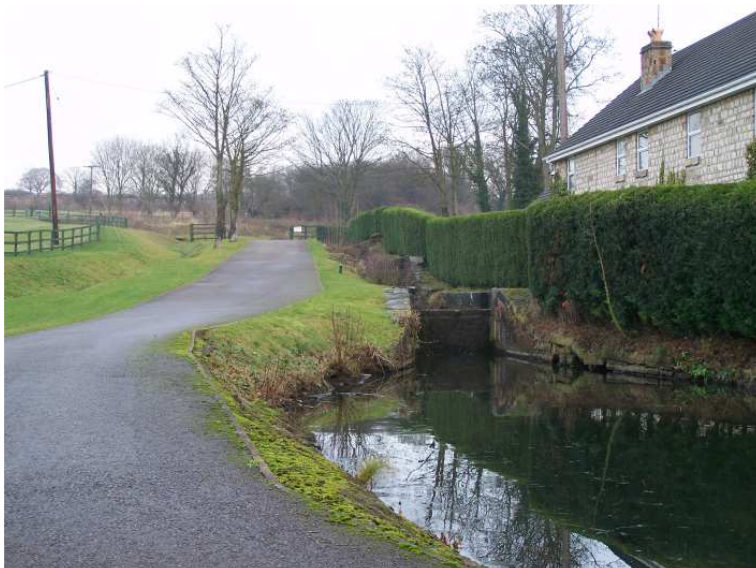
Figure 20.3

Norwood Low Treble Locks (No's 10, 11 & 12)

The building to the right is the much rebuilt Boatman's Inn, now a private house.

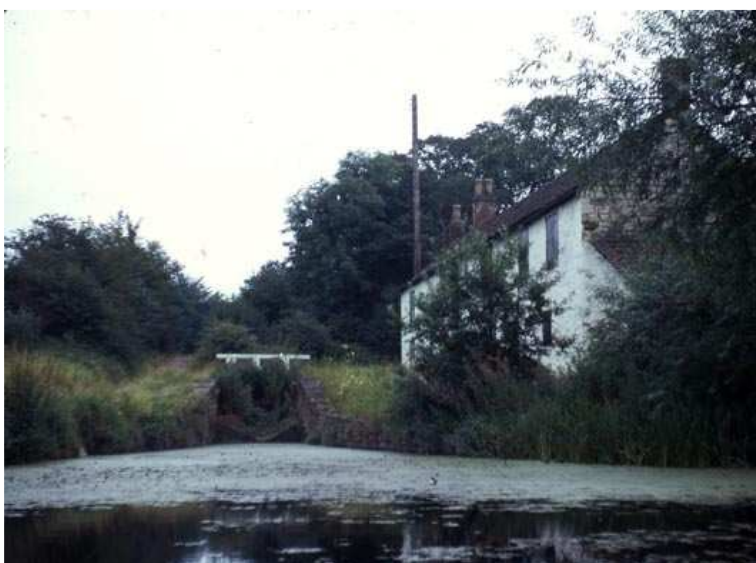
Figure 20.4

The Boatman Inn at Norwood in 1972.

The footbridge to the building can be seen crossing the lock chamber. No remains of the lock gate by this time. Photograph by Hugh Potter, with permission.

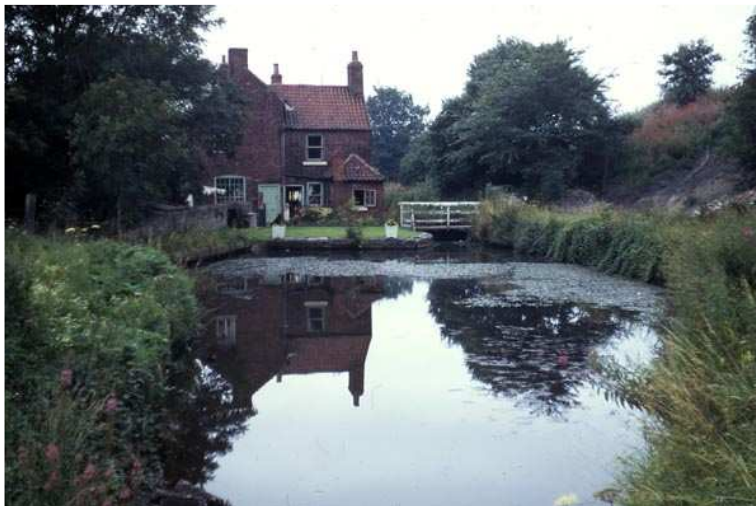
Figure 20.5

Norwood Lock Keepers House in 1972, looking west.

The house stood adjacent to the Norwood Lower Middle Treble Locks (No's 13,14,15). The white structure is a footbridge originally attached to the upper lock gate. The house has since been demolished. Photograph by Hugh Potter, with permission.

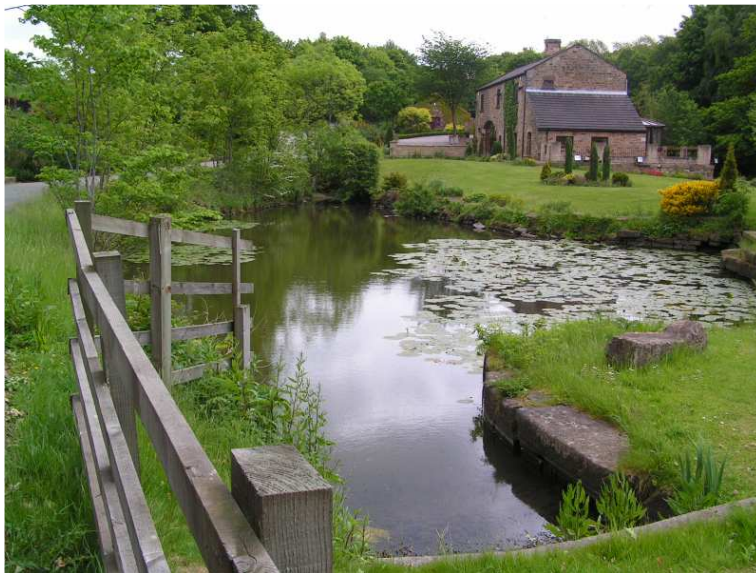
Figure 20.6

The former Norwood Sawmill (now a private house) looking east.

The narrows in the foreground is the top of the buried Norwood Lower Middle Treble Locks, the widening of the water to the right leads to the Middle Norwood Pond and straight ahead is the bottom of the Norwood Upper Middle Treble Locks. Ahead and right is the sawmill.

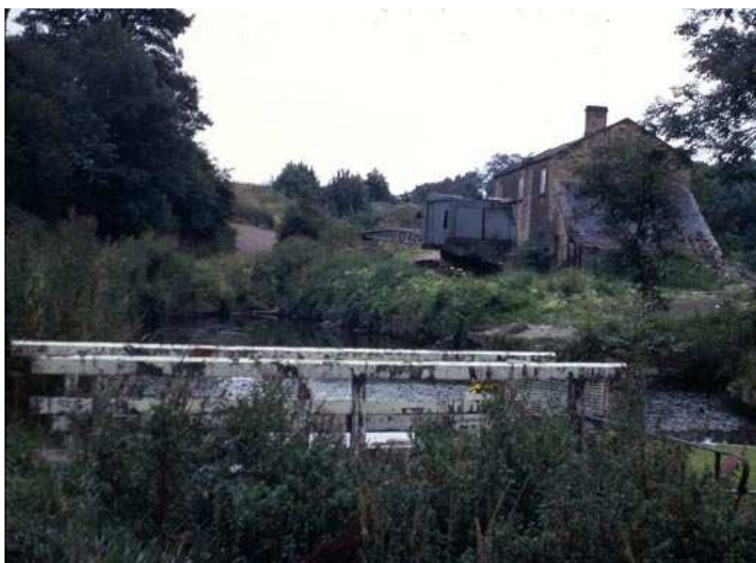
Figure 20.7

Norwood Sawmill from the west looking east in 1972.

The bridge in the foreground is the same as that in the previous plate. Photograph by Hugh Potter, with permission.

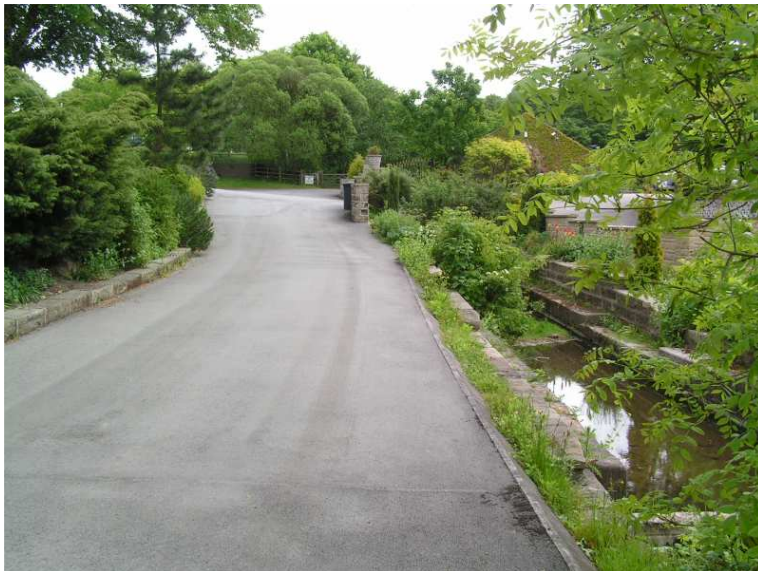
Figure
20.9

Norwood Upper
Middle Treble Locks
looking east.

The lock chambers are on
the right of the image.

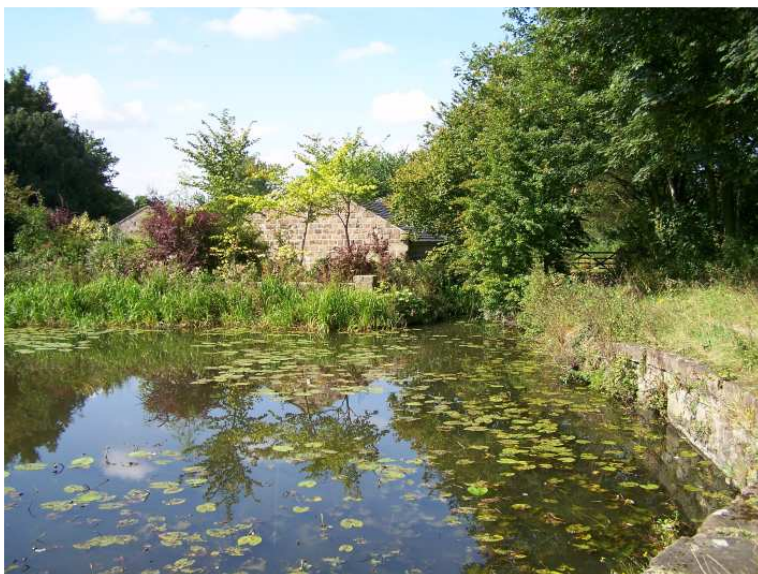
Figure
20.10

Top of the Upper
Middle Treble.

The locks were to the right
of the buildings, the
approximate site of the dry
dock was on the left of the
image.

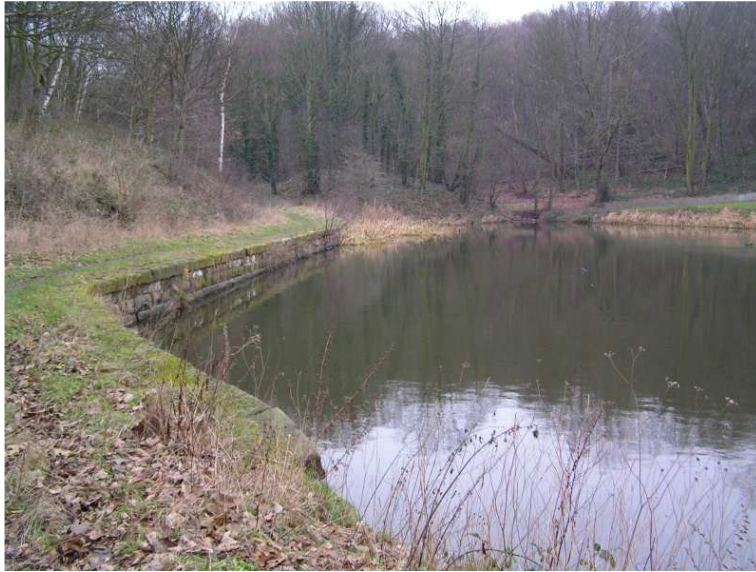
Figure 20.11

Norwood Upper Pond and West Kiveton Colliery Wharf

The wall on the left is the West Kiveton Colliery Wharf. The start of the four-rise is in the middle of the view.

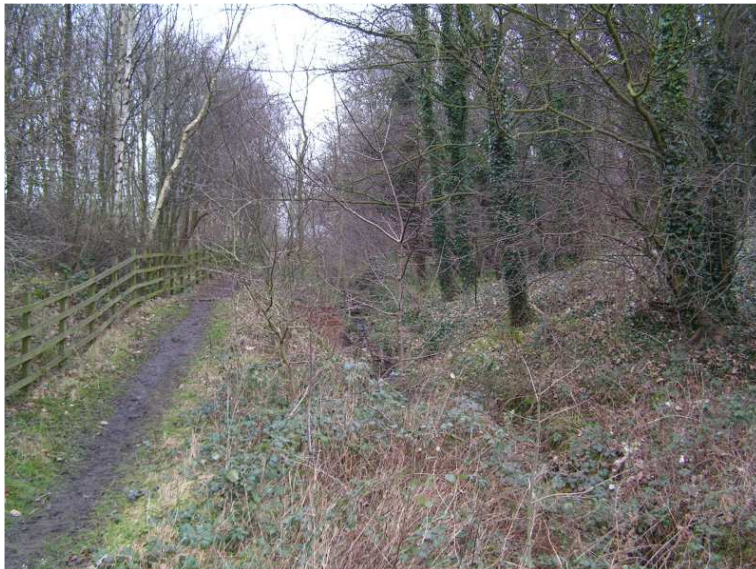
Figure 20.12

Norwood Upper Quad or Four-Rise Locks looking east.

Even in winter the vegetation growth makes the locks barely visible.

- 20.2.8 The upper four-rise locks will require vegetation clearance and the removal of young scrub woodland. The pound beyond, from the head of the four-rise to the west portal of the Norwood Tunnel, is in water although it is badly silted and partially infilled with reed growth. Some areas, especially on the off-bank are being encroached by thin Alder carr woodland. Clearance and dredging of this channel will result in some loss of that habitat and steps are being taken to identify areas where compensatory habitat can be created.

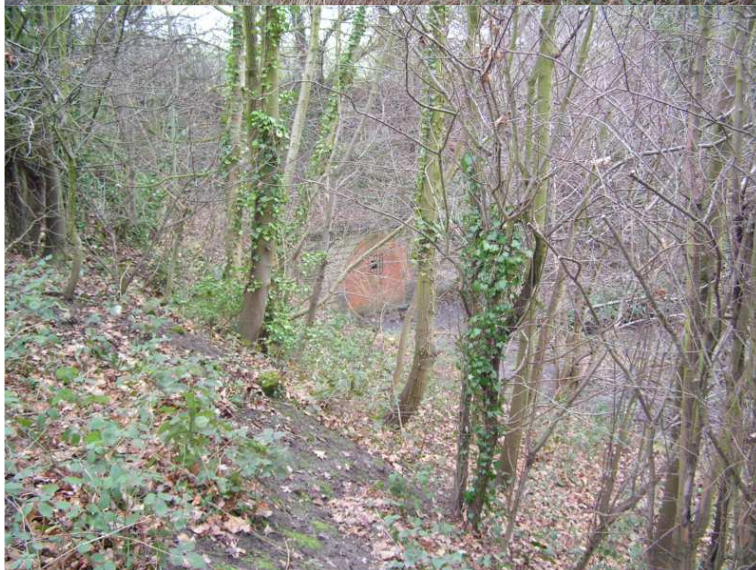
Figure 20.13

Norwood Tunnel West Portal seen through woodland, looking east.

Note opening. Water runs to the foot of the portal.
